A STUDY OF FATIGUE PROCESSES IN THE MATERIAL OF THE COMPRESSOR BLADES OF A GAS TURBINE ENGINE AFTER LONG-TERM OPERATION

I. N. Tsareva^{a)*}, O. B. Berdnik^{b)}, and S. V. Kirikov^{c)}

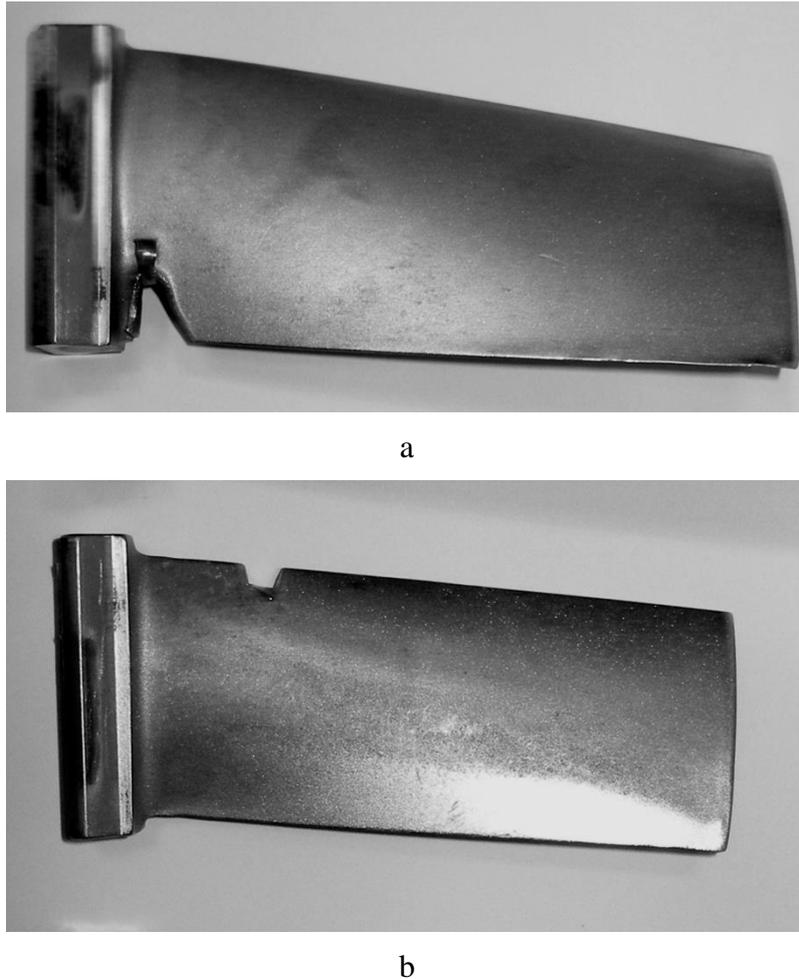
The compressor rotor blades are made of martensitic chromium stainless steel with the following elemental composition: 12.80 % Cr, 0.20 % C, 0.45 % Ni, 0.44 % Mn, 0.30 % Si, 0.07 % Mo, 0.16 % Cu. The phase composition of the blade material in the initial state is α -Fe + Fe $_3$ C. A nickel-based protective galvanic coating is applied onto the surface of the blades in order to protect the blades from pitting corrosion. The material condition was studied on blades of the 0th stage, which operate at a minimum temperature ($\sim 100 \text{ }^\circ\text{C}$), and on blades of the 5th stage, which are subjected to high temperature loads (up to $300 \text{ }^\circ\text{C}$), during operation. It was found by optical visual inspection that the coating on the surface of the blades is almost completely worn out after prolonged operation due to the erosive effect of a heated air flow (fig. 1). Numerous centers of pitting corrosion with a depth of 0.05 to 0.30 mm were found on the surface of the blades. The blades of all stages are prone to corrosion, and it is most pronounced in the zone near the exit edge. Some blades retain a small part of the coating near the exit edge (10 to 20 % of the total area). There are single mechanical nicks on the edges. Metallographic analysis has shown that the microstructure of the material of the 0th-stage blade root, less affected by heating during operation, is close to the initial state of the 20Kh13 steel. It is sorbitic pearlite with a round-grained carbide phase (Fe $_3$ C), fig. 2 a. The microstructure of the airfoil material is similar to that in the state of the blade root material (fig. 2 b). In this case, there are processes of coagulation of the carbide phase, which are manifested locally.

Fig. 1. The blades of the 0th (a) and 5th (b) stages after operation for 110,000 hours

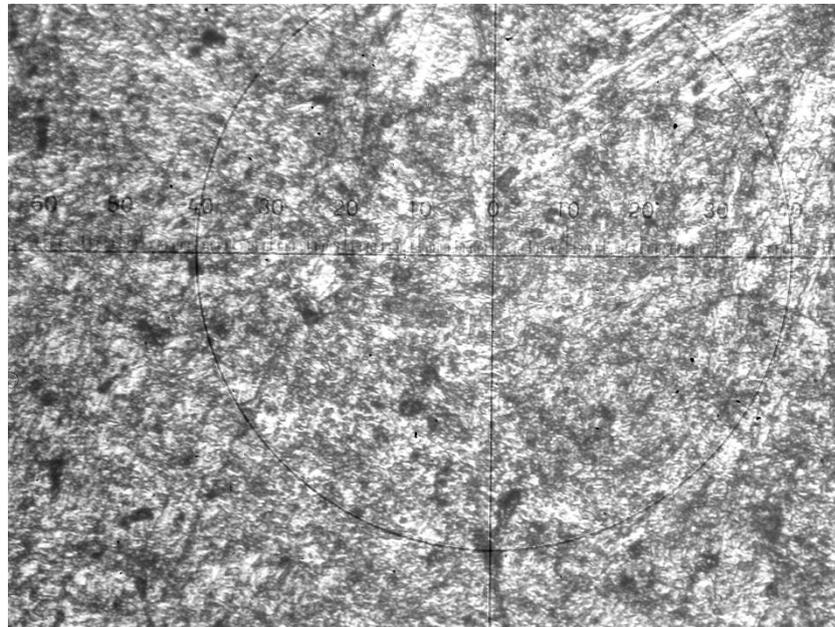
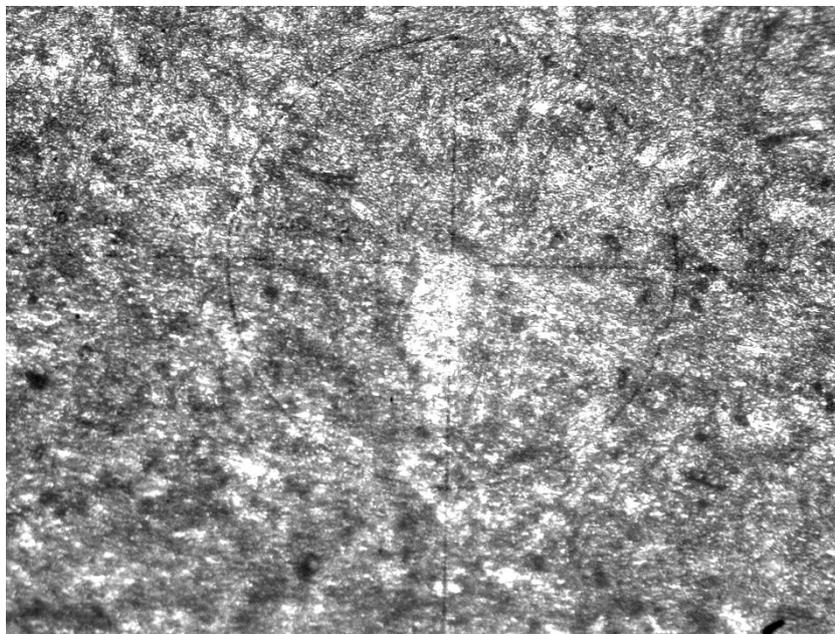
Fig. 2. Material microstructure in the root (a) and airfoil (b) of the 0th-stage working blade, ×500

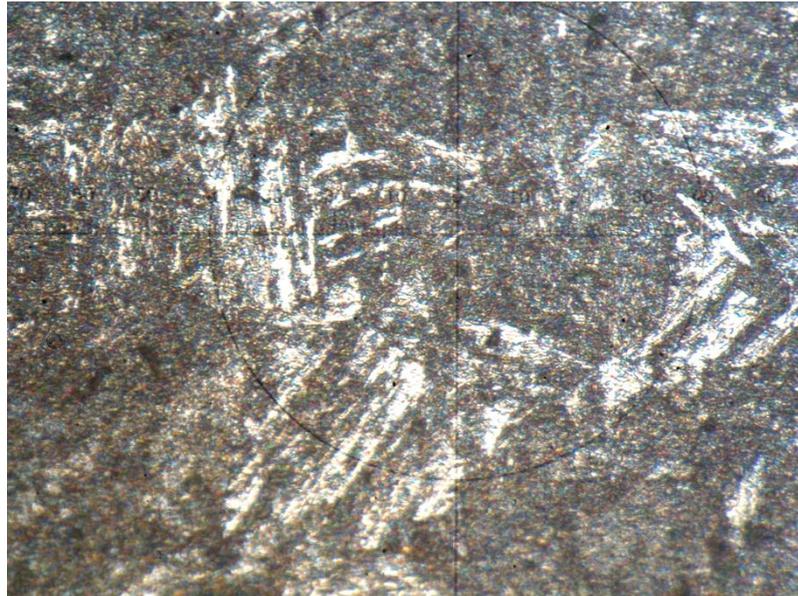
After long-term operation, the microstructure of the material of the airfoil of the 5th-stage blade, subjected to the highest specific workloads during operation, is lamellar pearlite (fig. 3). Internal microporosity was found in the material of the blades, which is typical for the stage of damage accumulation in the development of fatigue processes. The porosity is $\sim 3\%$ in the airfoil material and above $\sim 5\%$ in the material of the blade root, which is a non-stagnant zone.

Fig. 3. Material microstructure in the airfoil of the 5th-stage working blade, $\times 500$
